THE GALILEO HIGH GAIN ANTENNA DEPLOYMENT ANOMALY

Michael R. Johnson *

ABSTRACT

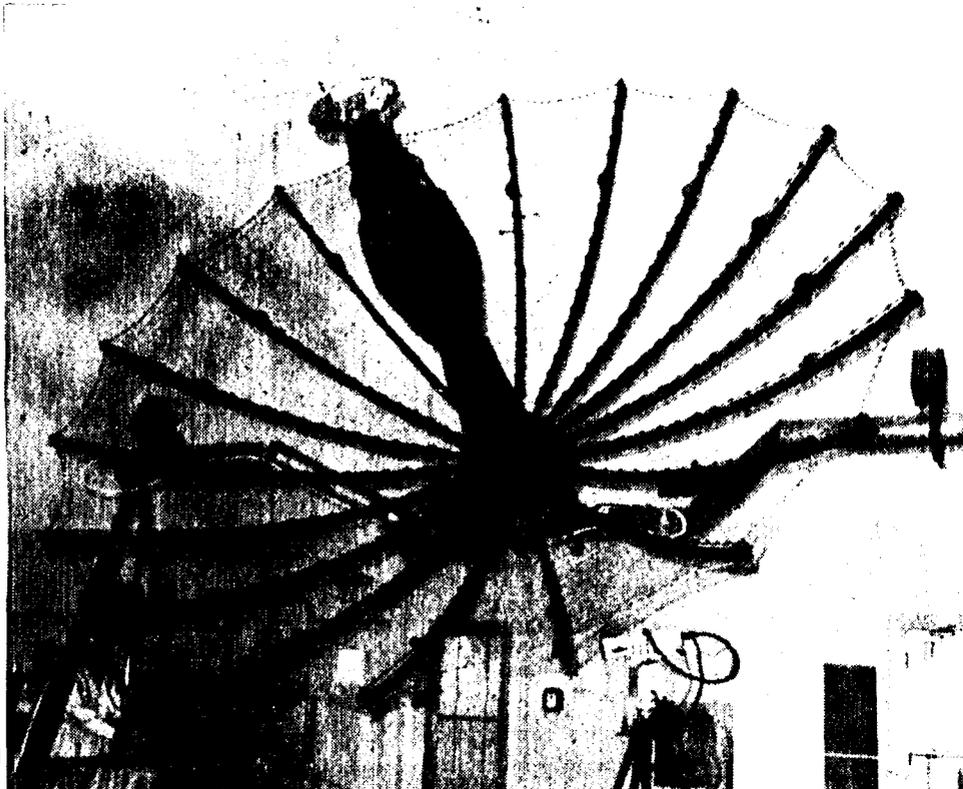
Figure 3.
High Gain Antenna
Deployed Position

The first conclusion that can be drawn from the Sun Gate data is that the output was reduced by the shadow of an antenna rib. Analysis of the Sun Gate's location with respect to the antenna shows that only one rib can shadow the Sun Gate and that this rib can only shadow it at deployment angles of 34 to 43 degrees given the spacecraft-to-sun angle at the time of the deploy attempt (5.39 degrees). Analysis of the amount of obscuration of the Sun Gate indicated that the one rib that can shadow the Sun Gate was deployed about 35 degrees from its stowed position.

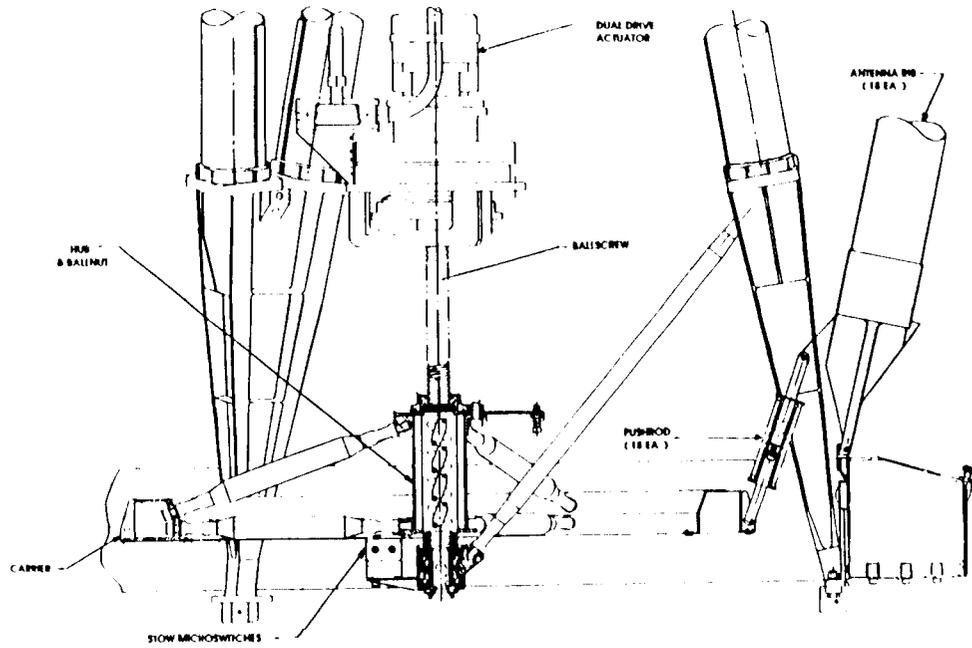
Figure 4.
Galileo High Gain Antenna Mechanical Drive System
(Stowed)

The Galileo High Gain Antenna is shown in Figure 2 in the stowed position, and Figure 3 shows the antenna in the deployed position. The HGA is deployed and stowed by a mechanism located in the base of the antenna called the Mechanical Drive System (MDS). This system consists of a Dual Drive Actuator^[1] (DDA), a 0.5 inch (12.7 mm) diameter, eight threads per inch (O. 125 in, 3.175 mm pitch) ballscrew/ballnut assembly, a carrier assembly, 18 pushrods, and 18 ribs. (Figure 4) The ribs have a gold-plated wire mesh connected to them that stretches and forms the reflector surface when the antenna is fully deployed. Figure 5 shows the Mechanical Drive System in the fully deployed position. The lower end of the ballscrew is supported by a bearing housing containing a radial roller bearing and two roller thrust bearings. As the ballscrew is turned by the DDA, the carrier, which is prevented from rotating by the pushrods, moves toward the DDA. This motion results in the pushrods forcing the ribs to rotate about their pivot point and open out like an umbrella. The motion of the ribs pulls the wire mesh out and stretches it tight, creating the reflector surface. The ribs open out until each rib fitting contacts a mechanical stop, preventing any further deployment of the rib. The continued motion of the carrier compresses a spring on each of the pushrods, preloading the ribs against their stops, and

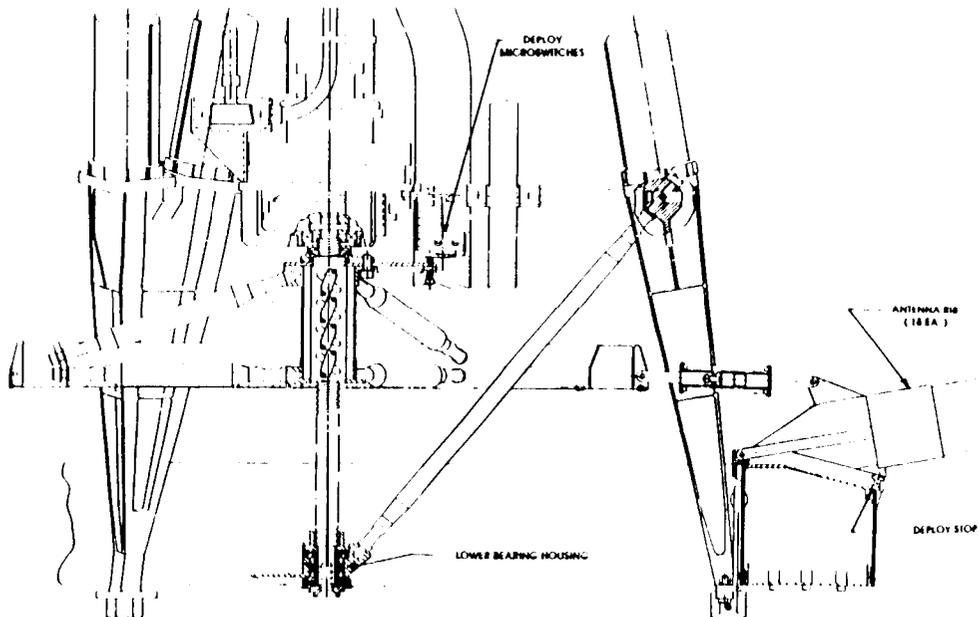
Figure 5.
Galileo High Gain Antenna Mechanical Drive System
(Deployed)

bearing housing (see Figure 5), due to the sliding contact of the ballscrew with the stationary outer housing. The needle roller bearing in the lower housing is not capable of supporting a large moment load, allowing the ballscrew to rotate relative to the housing and come in contact with it. The result of these torque losses was that very little torque was available to move the ribs against their restraints. -

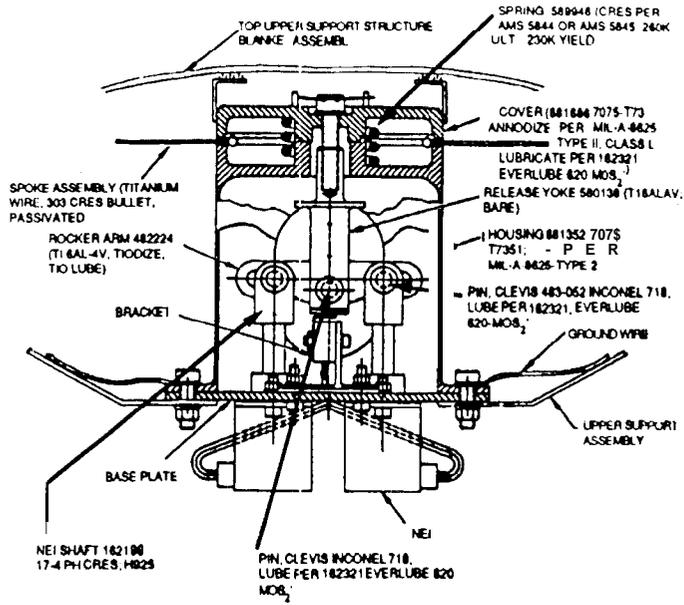
Figure 7,
Central Release Mechanism

Release Mechanism (Figure 7). This mechanism is opened by a spring when the retaining shaft, held in place by a

Non Explosive Initiator (NEI), is released, After launch, the Central Release Mechanism (CRM) is actuated, releasing all 18 spokes and allowing the MDS to deploy the antenna. For launch, the spoke assemblies are each preloaded to 378 N (85 lb) and this preload is reacted by two pin-socket combinations called the mid-point restraint (inset, Figure 8), Both pins are titanium 6Al-4V with spherical ends that engage the sockets. The pin receptacle design is shown in Figure 9. One receptacle is a cone, the other is a V-groove, they both have included angles of 90 degrees, and they are both made from Inconel 718. The reason for the different receptacle designs was to avoid multiple load paths in case the pins did not have the exact same separation as the receptacles. The two receptacles balance the tension from the spoke preload, the cone locates the rib in the plane of the receptacles, and the V-groove reacts any rotation about the cone receptacle. The tip restraint of the ribs is a pin (shown in Figure 6) in a tuning-fork-like receptacle, This design prevents rotations of the ribs about their mid-point restraints and allows the ribs to move out freely during deployment,

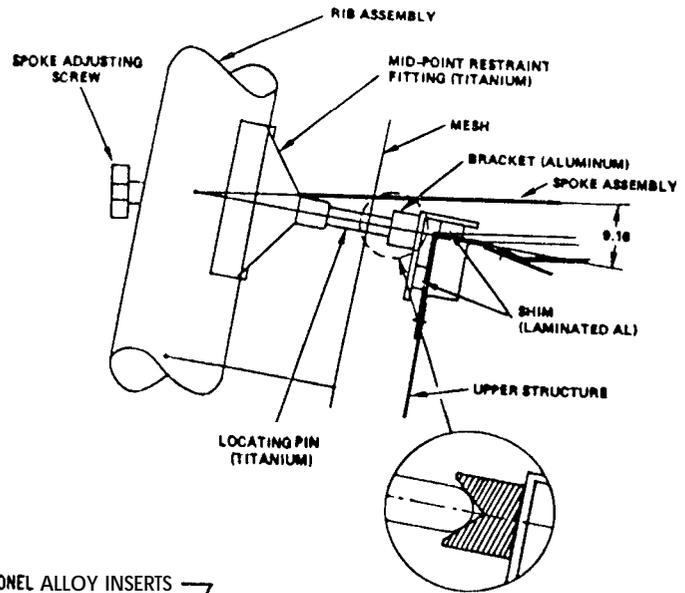
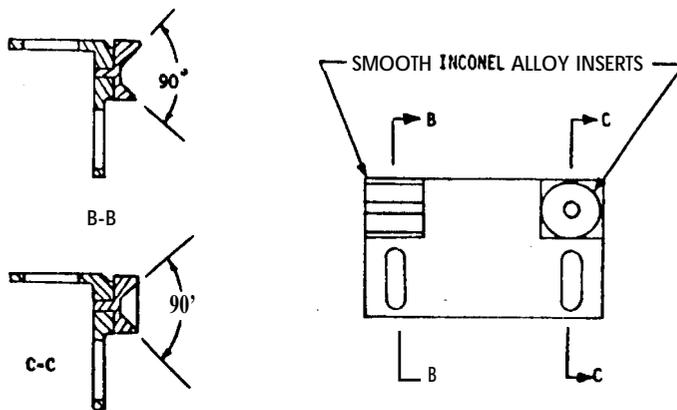
Figure 9.
Receptacle Design

The first time the ribs were stowed to their full preload, plastic deformation of the contact points on the V-groove pins destroyed the ceramic coating on the titanium that was the bonding surface for the drylube material. During the four trips across the country the antenna was exposed to enough of a vibration environment to cause relative motion between the pins and sockets. This motion was amplified by the cantilever mounting of the antenna in its shipping container. The pins that were on the top and bottom (with the antenna horizontal) saw the greatest amount of relative motion with respect to their sockets. Since this occurred in an atmosphere, the drylube surfaces on the pins were worn. During vibration testing of the antenna at JPL, further damage to the drylube occurred. The vibration testing was done along the same axis as the gravity vector during ground transport, causing the same pins and sockets to experience the greatest amount of relative motion. By launch, the drylube was probably completely worn off the contact points between the pins and V-groove sockets. After launch, the spacecraft was exposed to a vibration environment from the upper stage that caused more relative motion of the pins and sockets. Since this occurred in a vacuum with bare titanium pins, (due to the destruction of the contact patch on the V-groove receptacles) the pins and sockets galled together requiring more force to deploy the ribs than can be generated by the MDS.

The use of drylube, specifically molybdenum disulfide, on a mechanism that is going to be operated in an atmosphere should be carefully evaluated. The wear rate of the MoS₂ in air is so much higher than in a vacuum that any coatings could be worn out by in-air testing and not provide the desired lubrication when needed. The pins and sockets on the HGA that received the greatest amount of relative motion due to the shipping method were the same ones that were exercised most by the vibration testing. These are also the same pins and sockets that are stuck on the spacecraft. One solution to the problem of ambient testing

wearing out the lubricant coating would be to replace the lubricated components just prior to launch so there is a virgin lubricant surface for the flight operation.

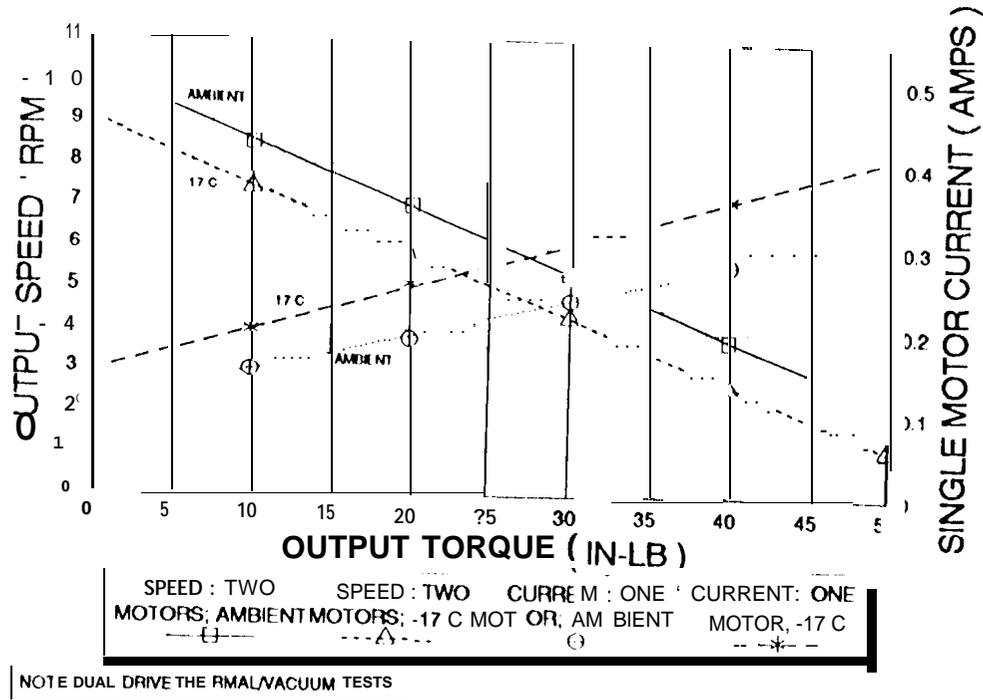
Figure 14.
Dual Drive Actuator Performance

The motor current telemetry indicated that the motors stalled at 56 seconds after initiation. The telemetry was then used to determine how far the ballscrew in the Mechanical Drive System had rotated from the stowed position. The motors on the DDA are brushless dc motors. The DDA, therefore, has the speed-torque-current relationship shown in Figure 14.

This allows the expression of speed as a function of current. Utilizing this relationship, the current telemetry from the spacecraft, and integrating over time allowed the determination of the ballscrew position as a function of time. Taking into account the granularity of the current telemetry, converting the current telemetry to torque, and plotting this as a function of ballscrew revolutions resulted in the curve shown in Figure 1 S. The data indicates that the ballscrew rotated just over five turns. (A full deployment requires 25 rotations of the ballscrew.) Converting the five rotations to carrier movement and then to rib rotation indicates that the ribs could not have deployed to an angle greater than 11 degrees, which is inconsistent with the Sun Gate data. The way the ribs are connected to the carrier allows for an asymmetric deployment of the ribs if one or more ribs are restrained by something. After several tests on the spare antenna, it was determined that the most likely configuration of the antenna was three ribs restrained at their stowed position. This would allow the opposite rib (over the Sun Gate) to deploy to the position indicated by the Sun Gate data. Also, the number of ballscrew revolutions and the torque required to deploy the antenna under these conditions is consistent with the current telemetry. Figure 16 is a photograph of the spare antenna in the three restrained rib configuration. This asymmetrical configuration is also consistent with the amount of reduction in the spin rate and the increase in wobble.

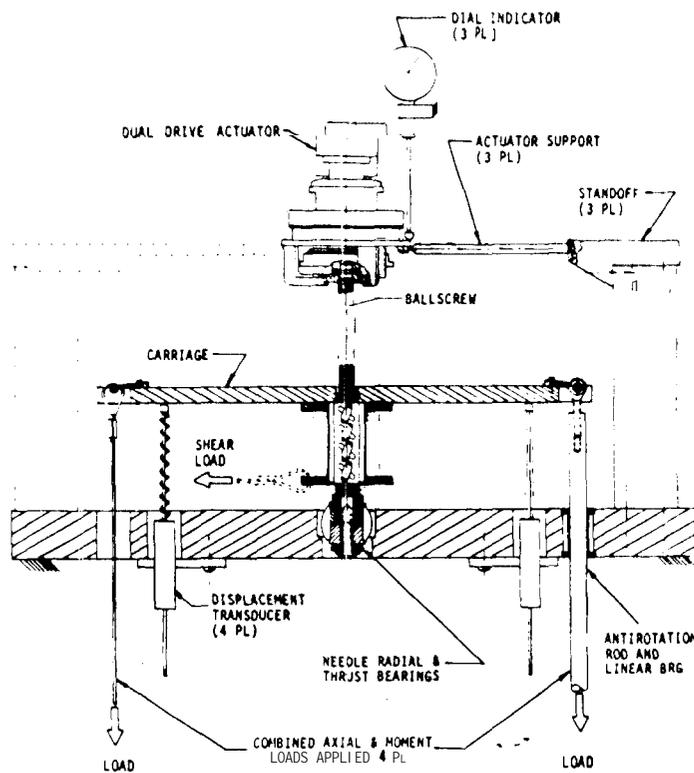
**Figure 17,
Mechanical Drive System
Loading Fixture**

was about 6.33 N-m (56 in-lb). A test was performed on a mock-up of the MDS to determine how it would respond to the odd loading condition created by the antenna. The test fixture shown in Figure 17 was used to apply moment, axial, and shear loads to the "carrier plate" individually and in combination. The results of these tests showed that shear and axial loads do not significantly affect the efficiency of a ballscrew. Moment loads, however, result in very significant losses in a ballscrew/ballnut assembly. The graphs in Figure 18 show that the application of a moment of 339 N-m (3000 in-lb) to a ballnut results in torque losses of 4.18 N-m (37 in-lb), or more than half of the available torque from the DDA. This large amount of torque loss is due to jamming of the balls in the ballnut and sliding contact of the ballscrew with the ballnut body. Also, it was found that further losses occurred at the lower
